DEPARTMENT OF TRANSPORTATION

Contract #: 04-0120F4Cty: SF/ALA Rte: 80 PM: 13.2/13.9File #: 69.28**WELDING INSPECTION REPORT****Resident Engineer:** Pursell, Gary**Address:** 333 Burma Road**City:** Oakland, CA 94607**Report No:** WIR-012072**Date Inspected:** 08-Feb-2010**Project Name:** SAS Superstructure**OSM Arrival Time:** 700**Prime Contractor:** American Bridge/Fluor Enterprises, a JV**OSM Departure Time:** 1900**Contractor:** Zhenhua Port Machinery Company, Ltd (ZPMC), Changxing Island **Location:** Shanghai, China

BAY 10**SOUTH TOWER LIFT 4 FIT LUG ON SKIN A**

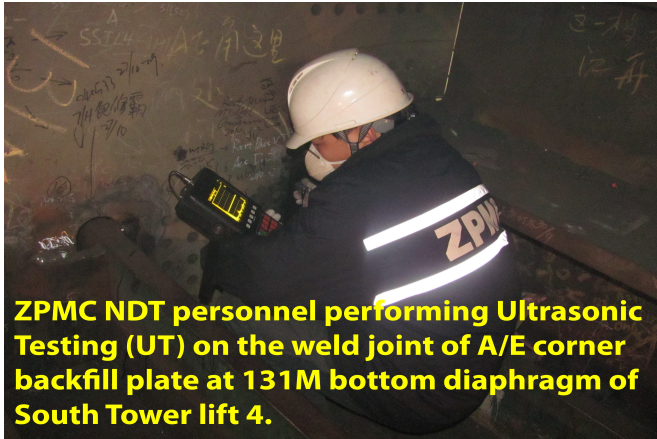
This QA inspector witnessed Ultrasonic Testing (UT) performed by ZPMC NDT personnel on the weld joints of A/E corner backfill plate of South Tower lift 4 at 127M and 131M diaphragm. The components are identified as Tower components. The weld designations are as follows. Attached photographs provide additional detail.

SSTL4-1G/L-29, 98

SSTL4-1H/L-30

ZPMC NDT personnel performing Ultrasonic Testing (UT) on the weld joint of A/E corner backfill plate at 131M bottom diaphragm of South Tower lift 4.

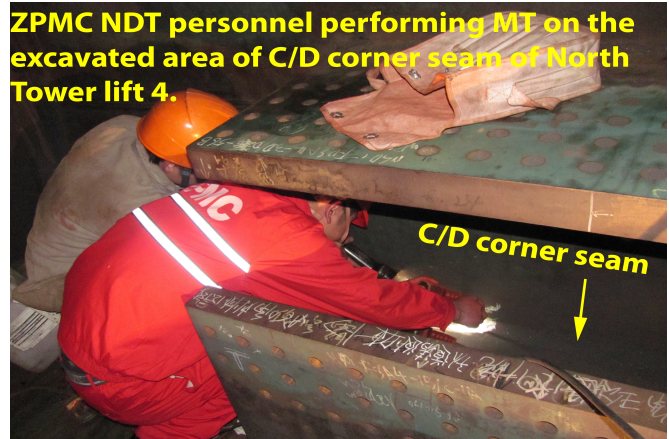
This QA inspector witnessed Magnetic Particle Testing (MT) performed by ZPMC NDT personnel on the excavated area of the repair locations of B/C corner seam and C/D corner seam of North Tower lift 2 at various locations. The components are identified as Tower components. The weld designations are as follows. Attached photographs provide additional detail.

NSTL4-3B/L-1A/B (C/D CORNER SEAM)

NSTL4-3B/L-5A/B (B/C CORNER SEAM)

ZPMC NDT personnel performing MT on the excavated area of C/D corner seam of North Tower lift 4.
